Reference Manual

Troubleshooting an Enphase Microinverter System

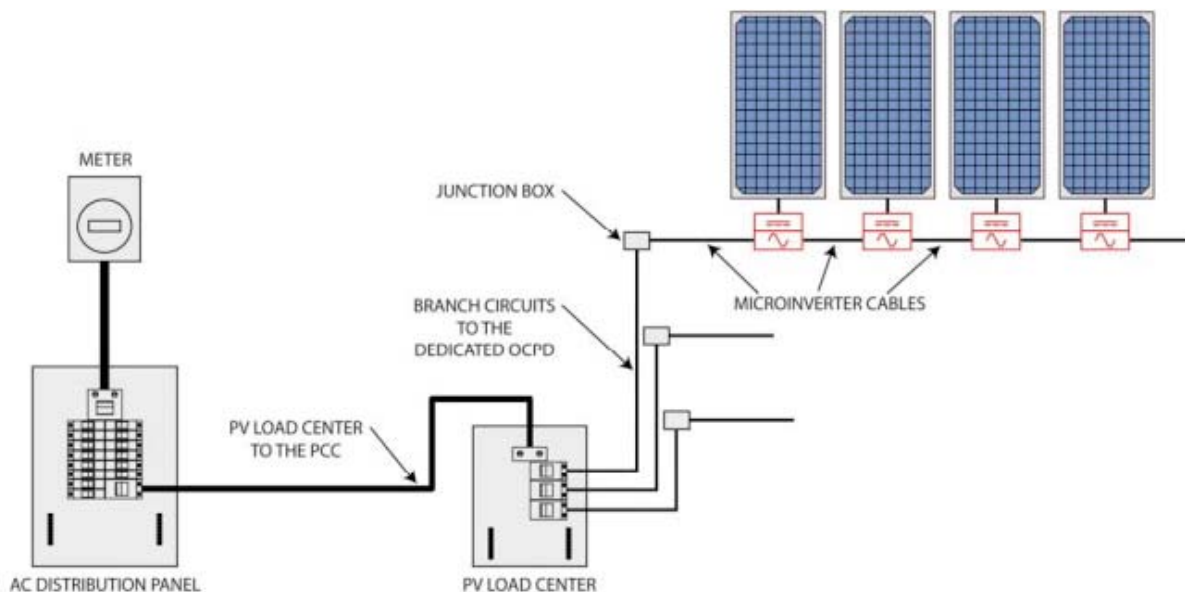
1. Measure voltages for L-L and L-N for all phase-conductors at the service entrance (PCC), at each Enphase branch circuit breaker, at each Enphase branch circuit junction box, at each Enphase branch circuit AC pigtail (if used in this installation), and at the last micro-inverter of each Enphase branch circuit.

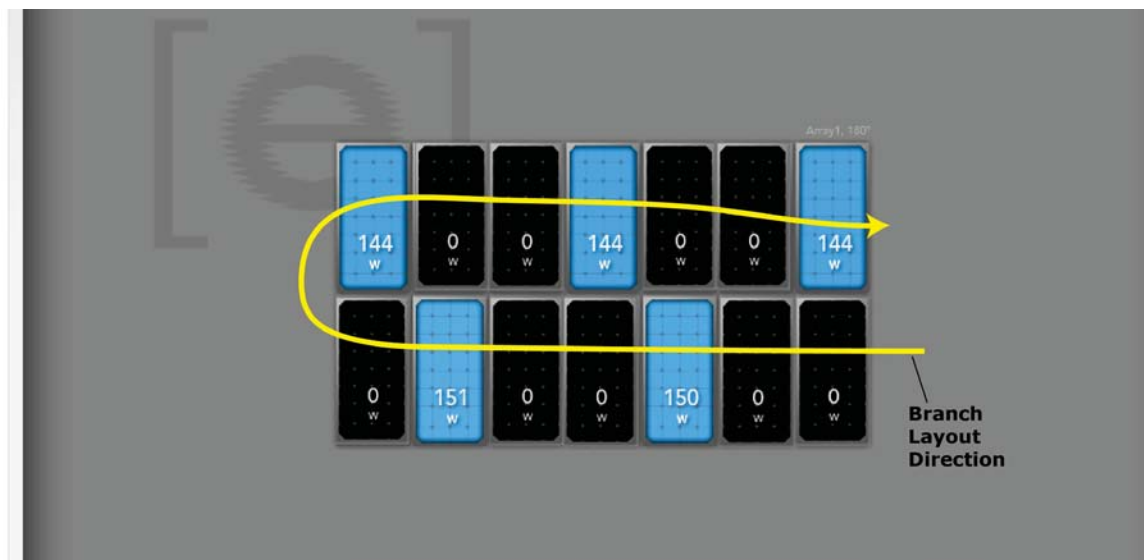
1. If the condition alternates among microinverters, incorrect cabling may be in use. The following Enlighten snapshot shows the result of using 208 Volt cabling at a site with 240 Volt service. Notice that only every third unit is productive.

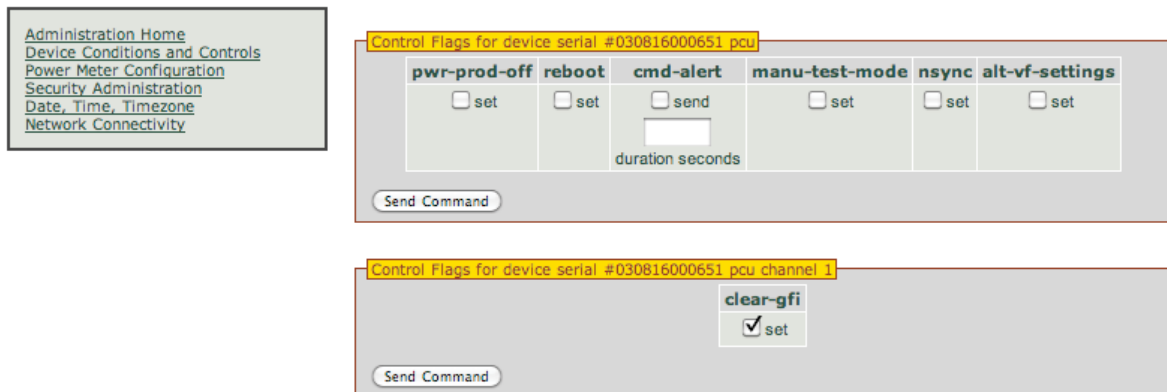
7. Click "Administration", and when prompted for credentials, enter the username as **admin** and the password as **admin**.
8. From the Admin menu, choose Device Conditions and Controls.
9. Click on the serial number of the unit exhibiting the GFI condition.
NOTE: Do not click or select the box under the column labeled "Select".
10. In the clear-gfi box, select "set".
11. Click "send command".

You can attempt to clear this condition through the Envoy Interface by sending the Clear-GFI message to the affected microinverter.

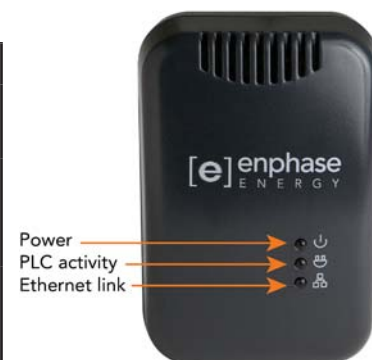
Use the status lights to verify connections. The table below describes the lights on the front panel of the unit.

Indicator	State	What it means
Power	On	Indicates device powered on
	Off	Indicates no power
PLC Activity	Blinking	Indicates activity on power line
	Off	Indicates no activity on power line (should blink intermittently)
Ethernet Link	On	Indicates Ethernet connectivity
	Blinking	Indicates Ethernet traffic
	Off	Indicates no Ethernet activity

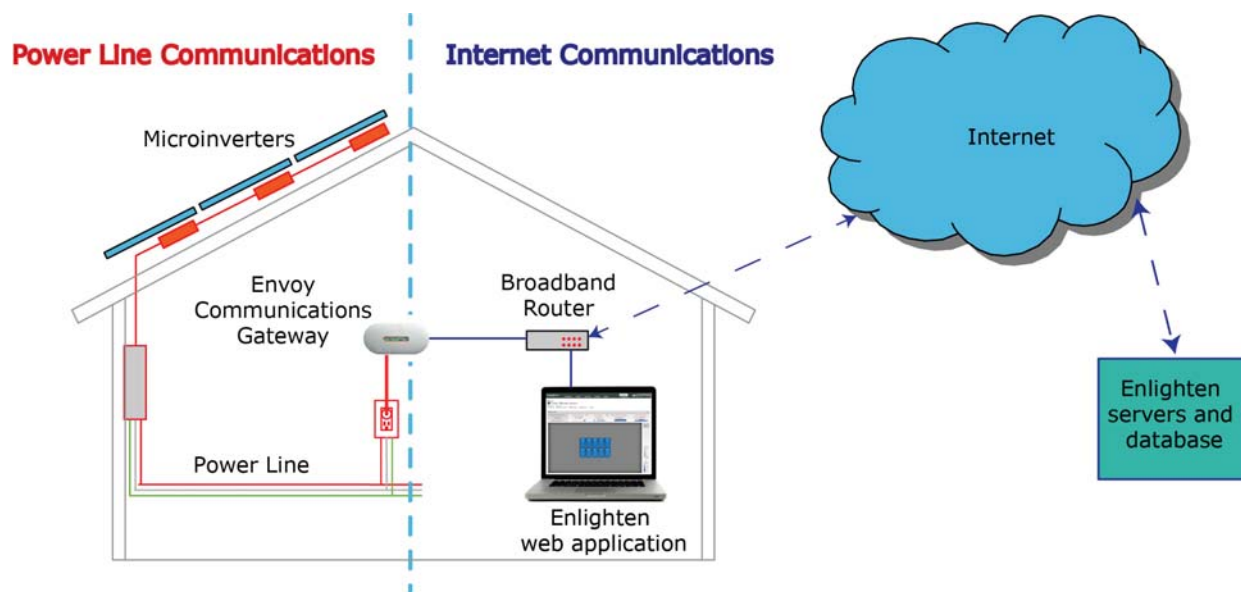
Power line communication between the Envoy and the microinverters is completely separate from the Envoy Internet communication. That is what makes the Envoy a "gateway device". One side of the Envoy communicates with the microinverters via the power lines. The other side of the Envoy communicates with the Internet using a standard Ethernet/network cable plugged into your broadband router.

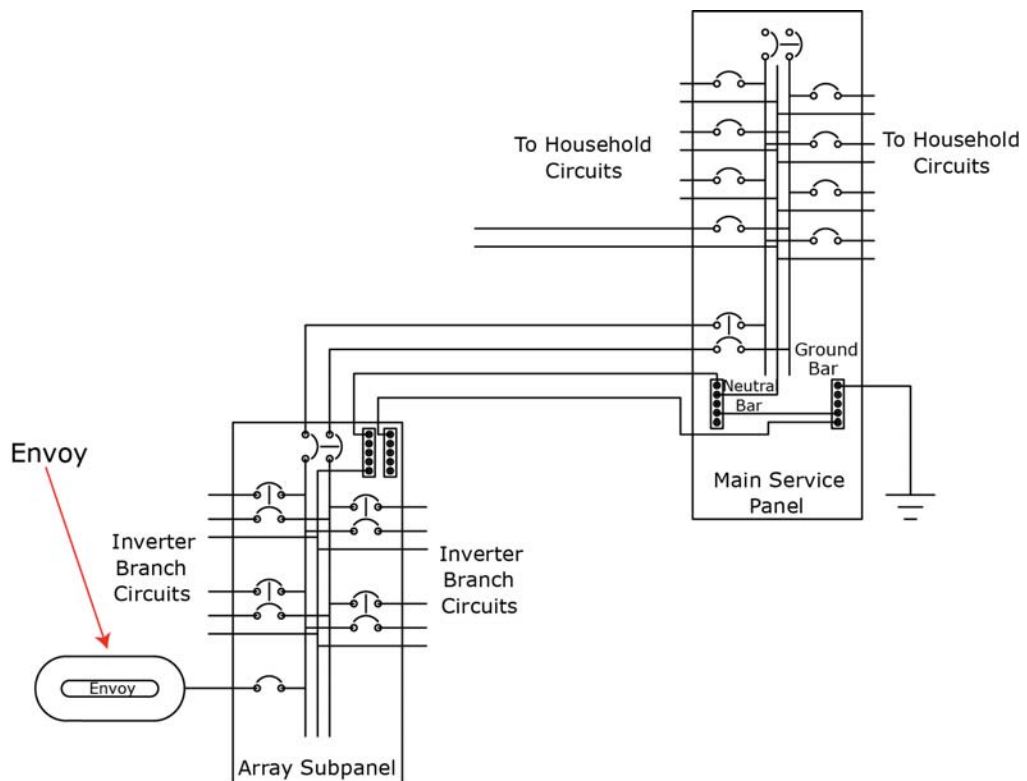
If the primary load-center is full, and doesn't have additional capacity to add circuit breakers for solar, the solar installer will sometimes add a subpanel, which is just another, "mini" load center with a small subset of circuit breakers. In these cases, it is best to add an additional 5-Amp circuit breaker and then run an outlet off of that subpanel. Plug the Envoy into that outlet, so that it can be close to the PV circuit breaker(s).

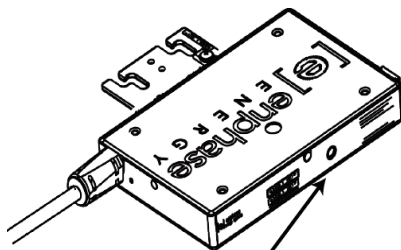
LED on long edge
of M190 and M210

Enphase microinverters carry LED indicators. On M190s, M210s, and D380, these LEDs are on the edge of the microinverter. On M215s, the LEDs are on the underside of the microinverter and may require a mechanics mirror for viewing once the microinverter is installed.

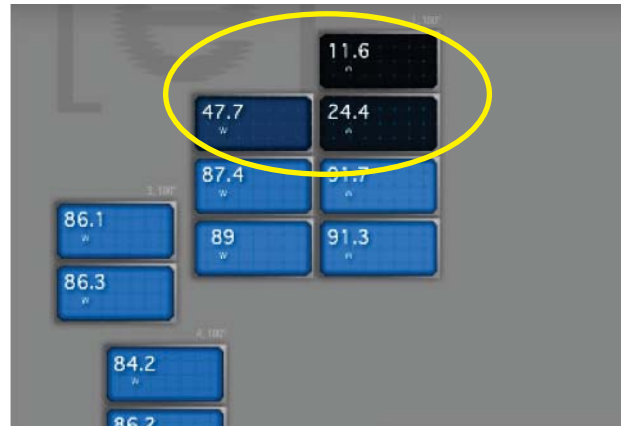
The 7-day time-lapse playback will give you a good idea whether a non-productive, or under producing PV/inverter pair shows repetitive production patterns that may be indicative of shading. The following Enlighten snapshot shows an example of a system with shading impacts.

If the periods of low production are fairly consistent and happen at the same time of day, shading is likely the cause.

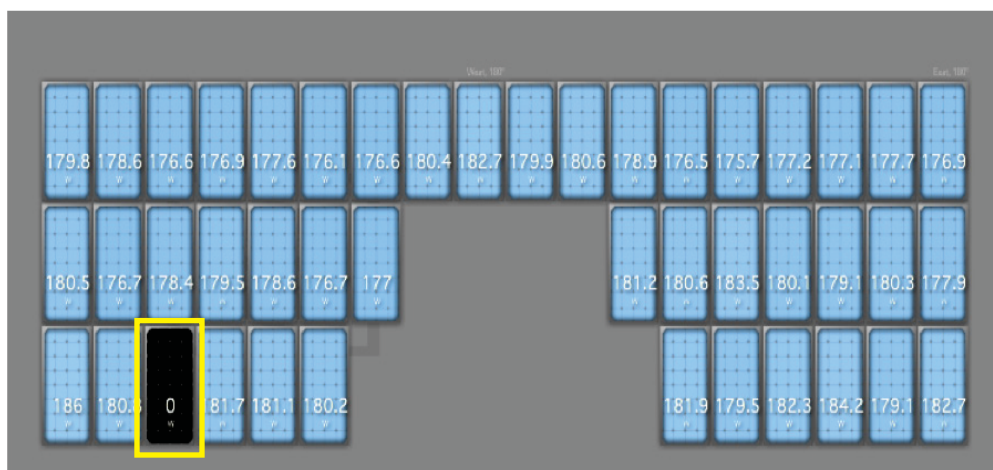
Why is one unit showing 0W production when adjacent units are productive?

This means the inverter is communicating, but not producing. A unit that is communicating, but not productive, may be experiencing a DC side failure.

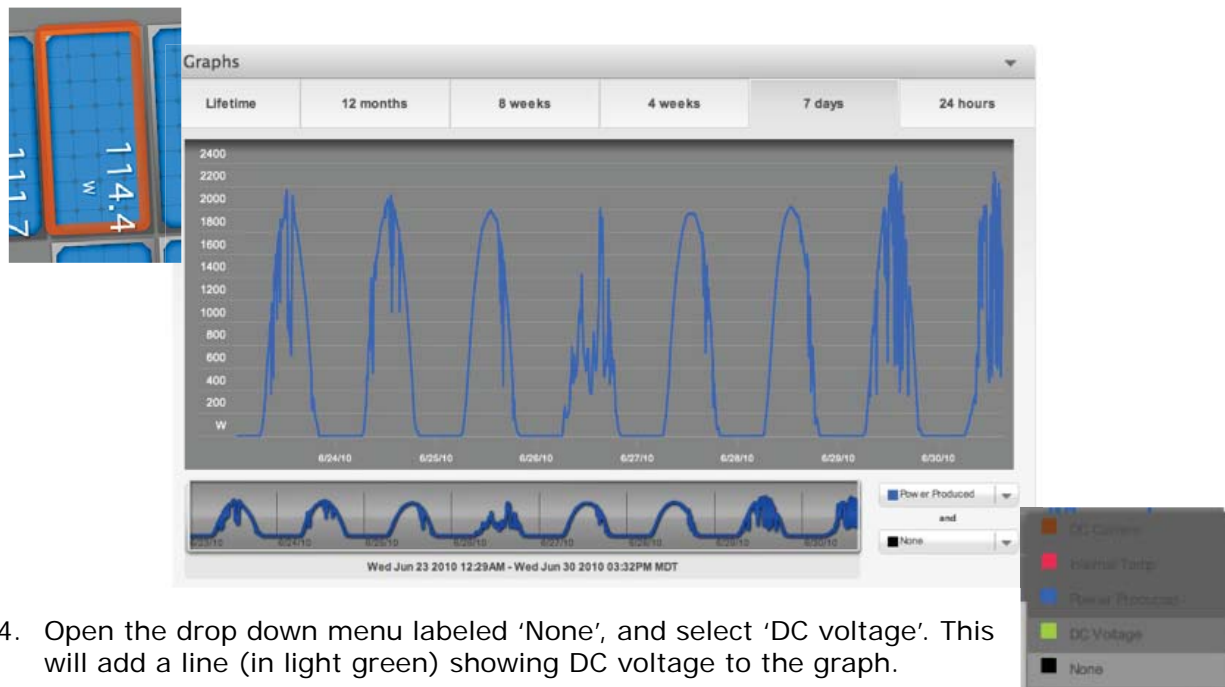
You can use Enlighten to gain a more detailed analysis of the problem. The DC measurements taken by the microinverter and viewable in Enlighten are key to identifying root cause of the problem. To view the DC measurements,

1. Click on the module under review in the Overview pane. The module will be highlighted (outlined with an orange box) after a few seconds.
2. Scroll down to the graphing pane.
3. Click on 7 days. The default view of the 7-day graph shows a production line in blue.

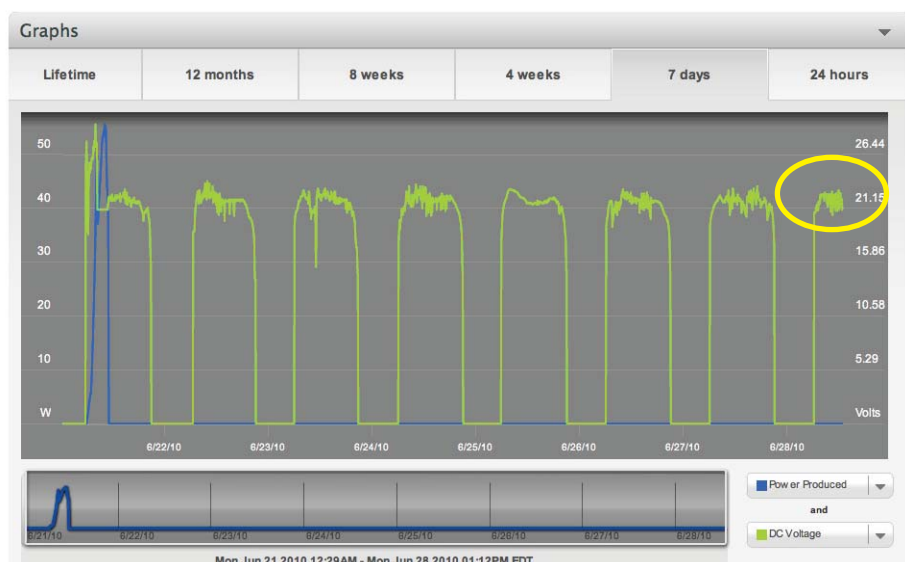
4. Open the drop down menu labeled 'None', and select 'DC voltage'. This will add a line (in light green) showing DC voltage to the graph.

In the following screen example, the microinverter under review reported production on 6/21/10, but did not report production after that. *This module reaches DC voltage of only ~21V after 6/21/10. The measured DC voltage after 6/21/10 was too low to power on the microinverter for energy harvest. It does not meet the required voltage to start up the microinverter.*

- The M190 and D380 models require DC voltage of at least **28V** to start up the inverter.
- The M210 model requires DC voltage of at least **38V**.
- The M215 model requires DC voltage of at least **26V**.

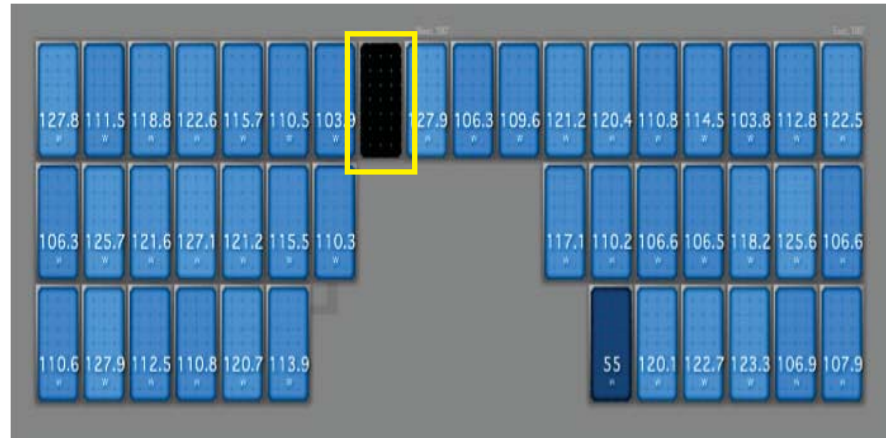
Modules that are shaded gray, with no indication of production level, have temporarily lost connectivity with the Envoy. This is different than a unit that is reporting, but reporting 0W AC power.

Communication outages may be caused by poor power line communications, or they may be caused by DC voltage that has slipped below the level required to turn on the inverter. Inverters that are not powered on will not communicate with the Envoy.
