165 VDC ETL TEST STORY

MidNite Solar orders custom made breakers for their PV applications from Circuit Breaker Industries in South Africa. These breakers come with a UL 489A listing of 125VDC with an interrupt rating of 10,000 amps. The UL voltage rating is not adequate for today's PV systems, so an additional agency listing is required.

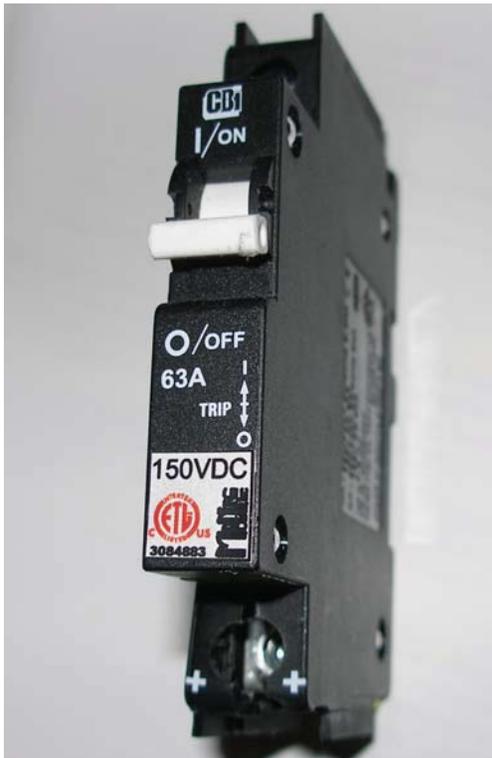
The breaker pictured is the MidNite MNEPV series breaker with the proposed ETL label installed. As of this writing, the label has not yet been submitted to ETL for approval, so production breakers may be labeled differently.

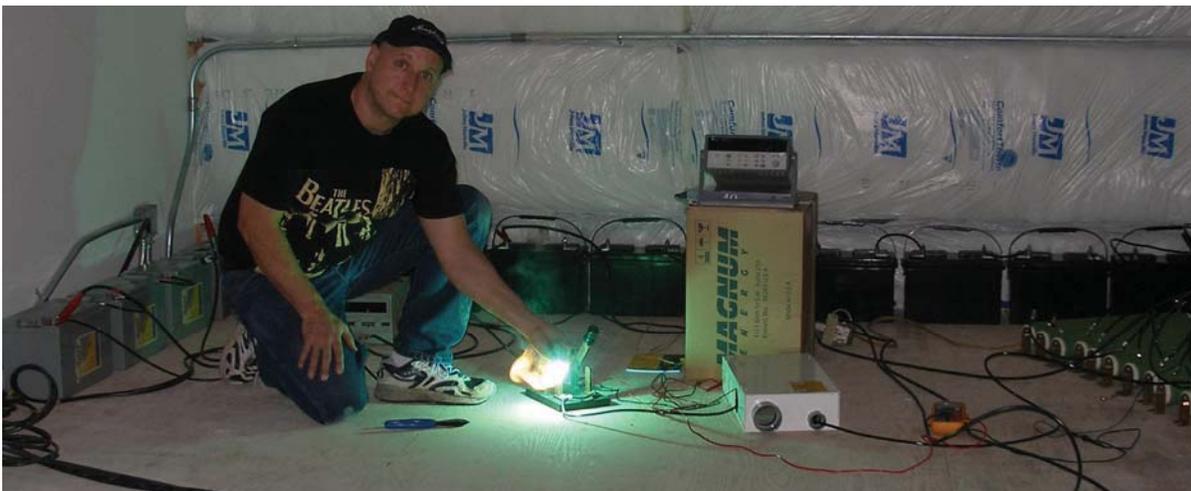
Pictured above, boB breaking 165VDC at 99 amps for the first test. This arc is the same arc that our little breaker must deal with internally. The arc is not only blinding, but also extremely hot. Pretty amazing huh! I also discovered the hard way that getting shocked with 165VDC feels pretty much the same as getting shocked with 120VAC.

The first test consisted of applying 165 volts of DC to the 63 amp breaker while running 99 amps of current through it. The test was done turning the breaker on for one second and then off for 9 seconds. This was done successfully 35 times. That was **16,335 watts** of high voltage DC the little breaker had to switch on and off. The first time we ran this prior to ETL being there, all we got was a melted down breaker fused solid in the closed position! It's a good thing we keep a hand on the knife switch for cases just like this. The breakers are marked with words stating "+ for DC". Now we better understand why this marking exists. We had it backwards and that doesn't allow the breakers internal arc shute to work effectively. Engineers rarely read directions before applying power to equipment. The + wording on the breaker was added by CBI on my recommendation years ago.
