Isolation Fault Troubleshooting - Application Note

Introduction

This document describes how to identify and locate an isolation fault in a SolarEdge system.

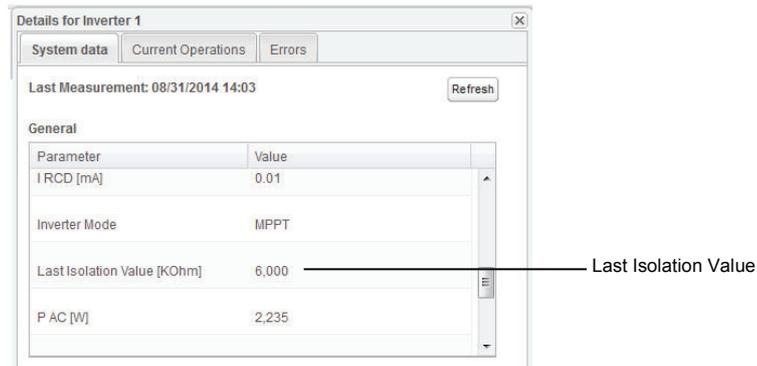
- 1 In the **Layout** window right-click on the inverter and select **Choose operations** → **Reset**.
- 2 Right-click on the inverter and select **Info** to display information about the inverter.
- 3 In the **General** parameter list, check the **Last Isolation Value**.

Figure 1: System data tab in the Details window

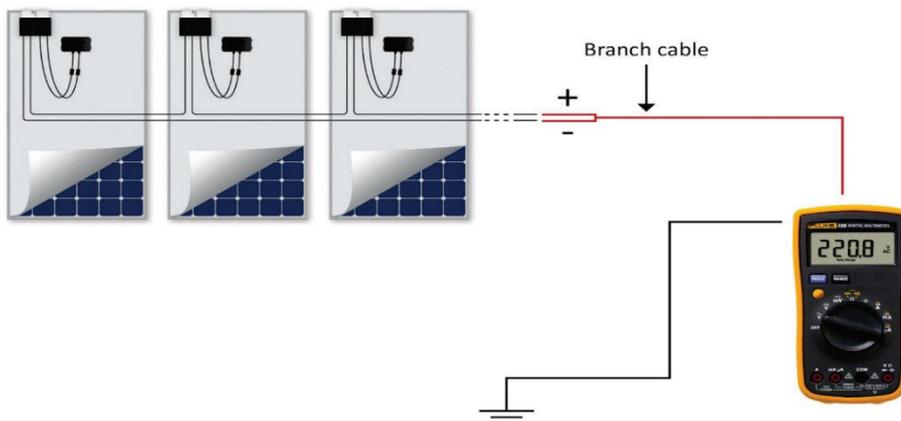
- 4** Test the *string resistance* using the insulation tester (see Figure 2):
 - a. Verify safe string voltage and current: max. 50V and 500mA.
 - b. Connect the positive and negative connectors of the first or last optimizer in the string to the branch cable.

- c. Connect the positive probe of the insulation tester to the branch cable.
 - d. Connect the negative probe of the insulation tester to a ground point.

- e. Select 500V testing on the insulation tester, or 1000V if required (e.g. to comply with NEN-EN-IEC 62446).
 - f. Test the insulation.

Figure 2: Connecting the insulation tester to the PV string

If the resistance is less than 600k Ω in a single phase inverter or less than 1M Ω in a three phase inverter, continue checking this string's components to isolate the source of leakage, as detailed in the following steps. Always make sure to connect both negative and positive output connectors to the tester using a branch cable.

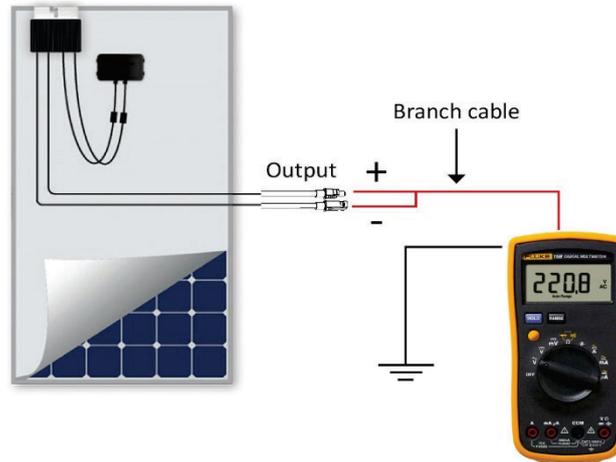
- 5** Test the *power optimizers' and modules' resistance* using the insulation tester (see Figure 3):
 - a. Disconnect the power optimizer from the string; it should remain connected to the PV module.
 - b. Verify safe power optimizer voltage and current: max. 1V and 500mA.

- c. Connect the power optimizer's positive and negative *output* connectors to the branch cable.

- d. Connect the positive probe of the insulation tester to the branch cable.
- e. Connect the negative probe of the insulation tester to a ground point.
- f. Select 500V testing on the insulation tester, or 1000V if required (e.g. to comply with NEN-EN-IEC 62446). If the measured resistance is 200MΩ or more, the power optimizer and module are not faulty. If the measured value is less than 200MΩ, the optimizer, the module or both are faulty. Continue checking as detailed in the following steps.

Figure 3: Connecting the insulation tester to the power optimizer and module

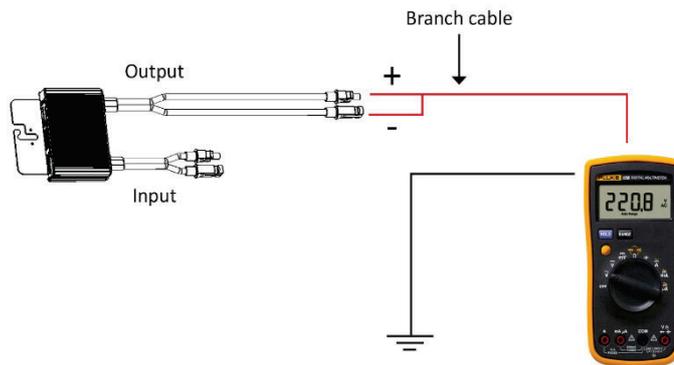
- 6** Find whether the leakage is from the module or from the power optimizer. Test each component individually by measuring the resistance between negative wires and ground:
 - a. Disconnect the module from the power optimizer.
 - b. Connect the power optimizer's positive and negative *output* connectors to the branch cable (see Figure 4).
 - c. Connect the positive probe of the insulation tester to the branch cable.
 - d. Connect the negative probe of the insulation tester to the power optimizer frame (ground point).
 - e. Select 500V testing on the insulation tester, or 1000V if required (e.g. to comply with NEN-EN-IEC 62446).
 - f. Measure the resistance; if the value is 200MΩ or more – the module is faulty; if the value is less than 200MΩ, replace the optimizer and test the module in case it is faulty as well.

Figure 4: Connecting the insulation tester to the power optimizer

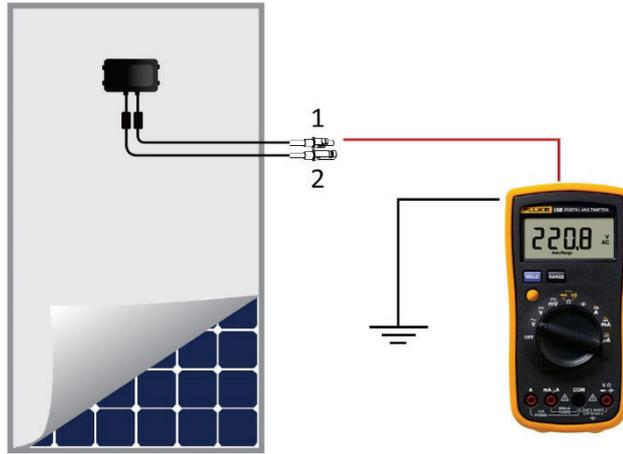
- g. Disconnect the branch cable from the power optimizer.
- h. Connect the one of the module's input cables to the positive probe of the insulation tester and connect the negative probe of the insulation tester to a ground point (see Figure 5).
- i. Measure the output resistance, if the value is less than 500MΩ, the module is faulty. If the value is 500MΩ or more, repeat for the other input cable. If the value is less than 500MΩ, the module is faulty; if the value is 500MΩ or more – the module is OK.

Figure 5: Connecting the insulation tester to the module
